PAPAYA  
Digital X-ray System

Dental X-ray Imaging system

Panoramic  
Cephalometric  
Tomography

# New Concept/Multi-functional Imaging System, PAPAYA PLUS

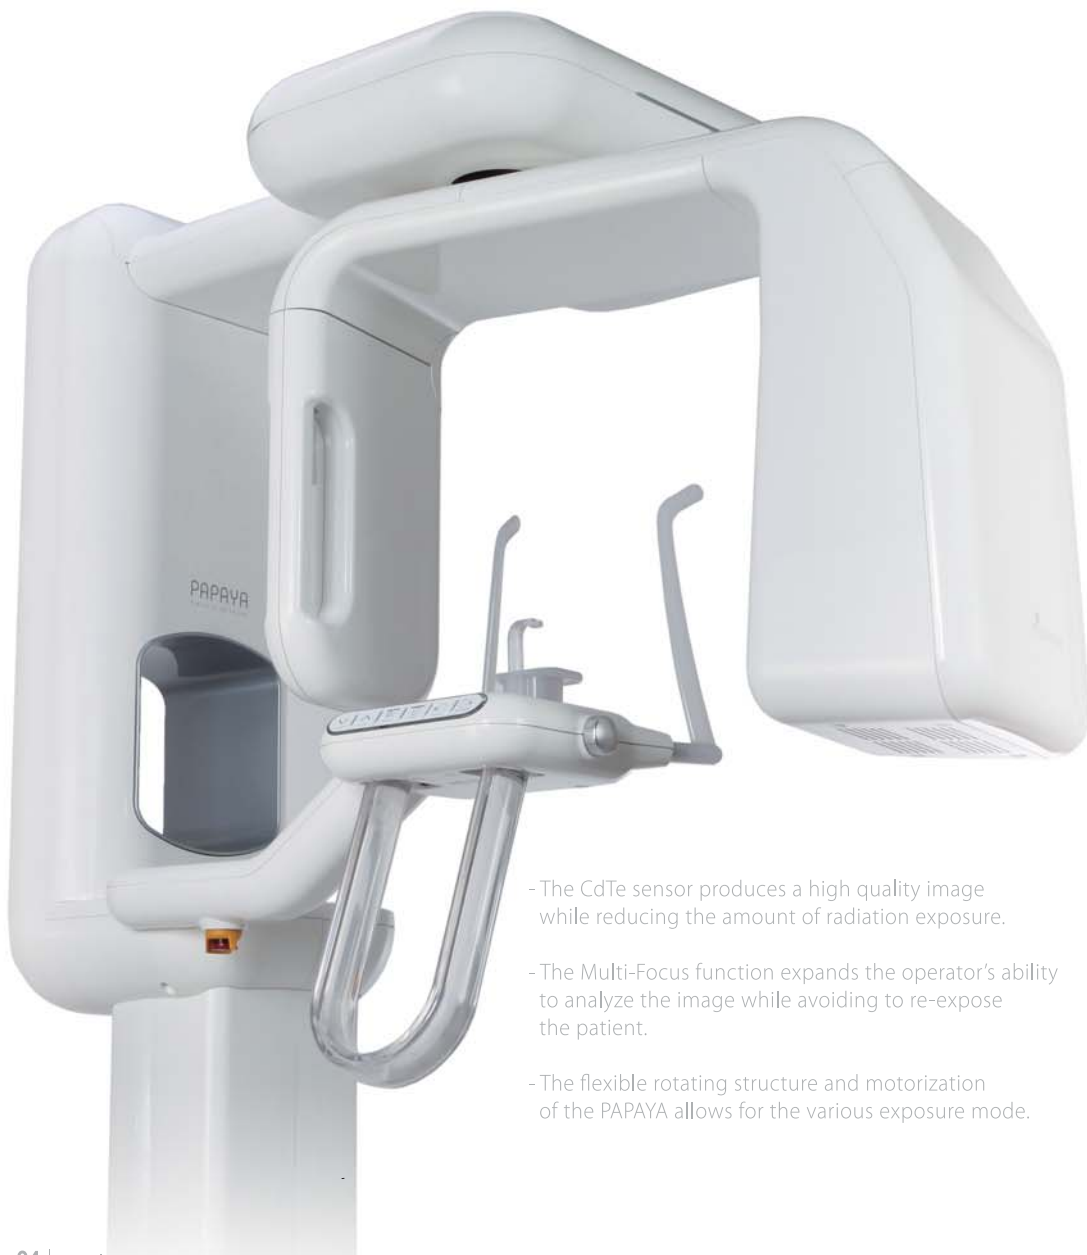
High Resolution Panoramic Technology

- The CdTe sensor produces a high quality image while reducing the amount of radiation exposure.
- The Multi-Focus function expands the operator's ability to analyze the image while avoiding to re-expose the patient.
- The flexible rotating structure and motorization of the PAPAYA allows for the various exposure mode.

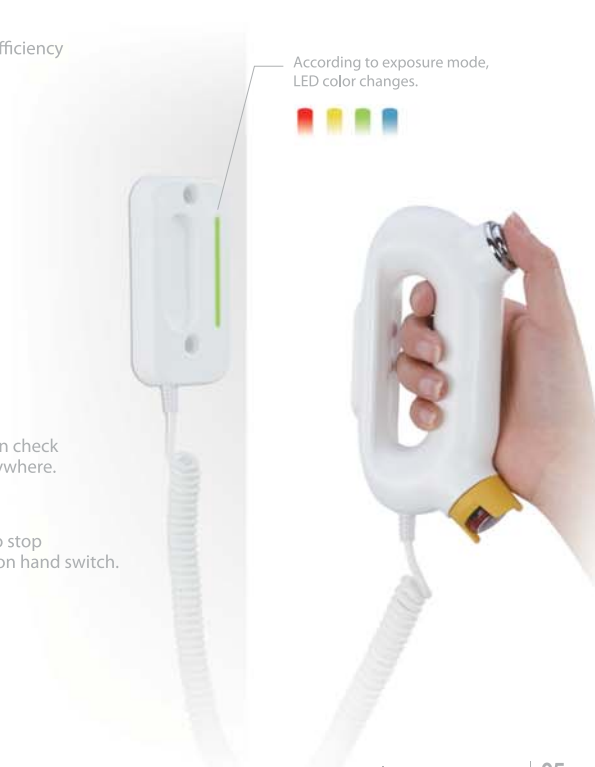
According to exposure mode, LED color changes.

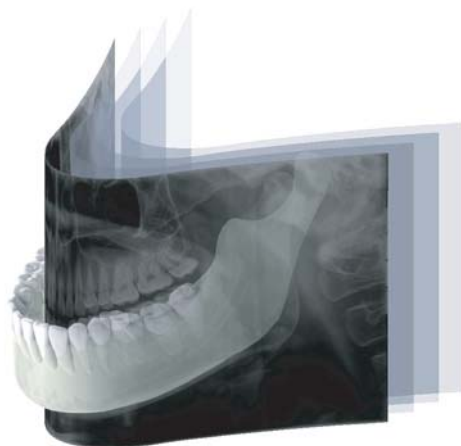
## Multi-Focus Function

Multi-focus function ables to overcome operator's mistake from patient's faulty positioning and re-exposing X-ray. By reconstructing image with software way, the panoramic images layer can be corrected by multi-focus function.

Only one scanning and acquired multiple image with maximum of 5 slices. It's slice interval can be varying 0.1 to 5mm.

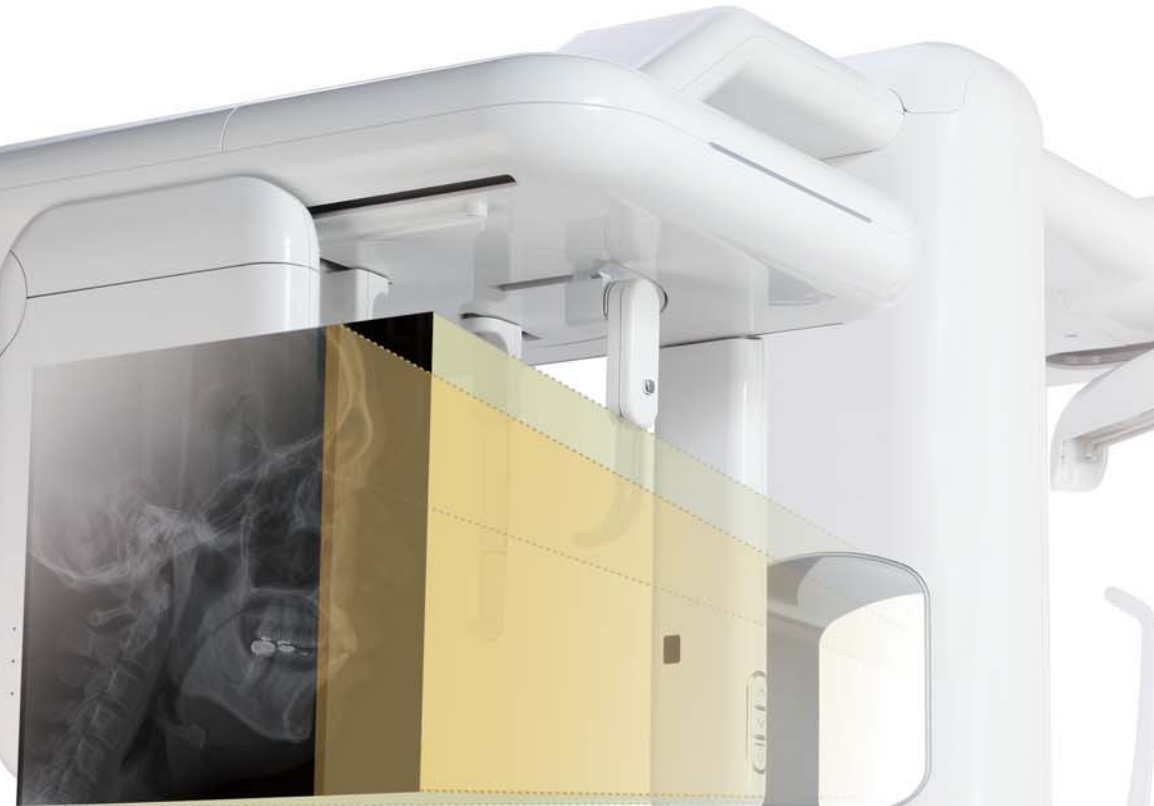
High Resolution Cephalometric Technology

- The optimized mechanical structure designed for symmetrical balance that is made for enhanced safety and durability.
- The Cephalometric's FR laser makes it easy to position the patient.
- To avoid any operating mistakes, the position sensing sensor aids in the every exposure mode.
- It is enough only 4 second for scanning cephalo image on fast mode. This reduces motion artifacts.
